Preliminary Monitoring Results Fraylemaborg, Slochteren

*Hanze University of Applied Sciences
Research Centre NoorderRuimte*

25.01.2019

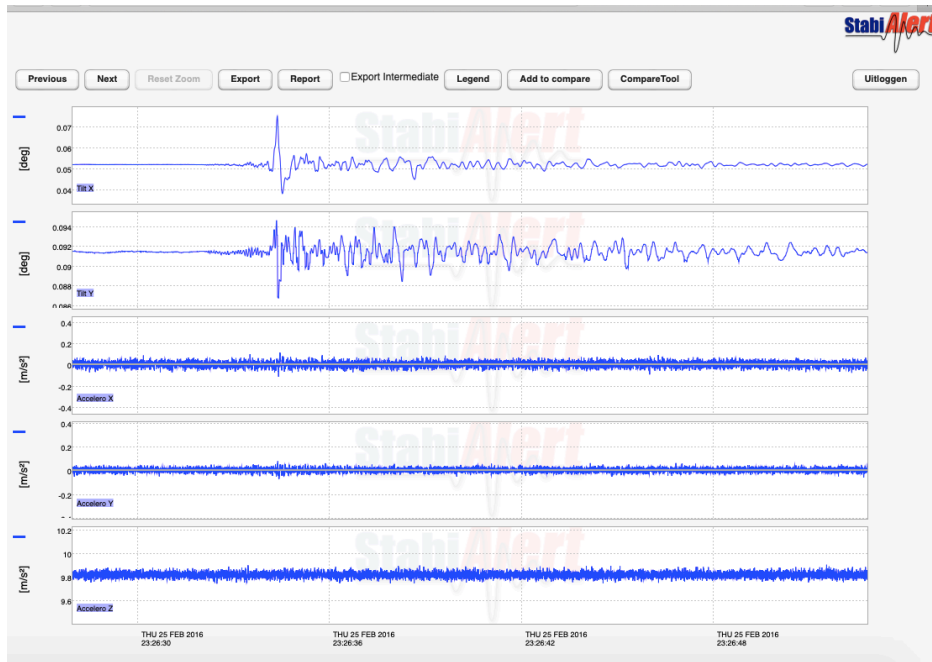
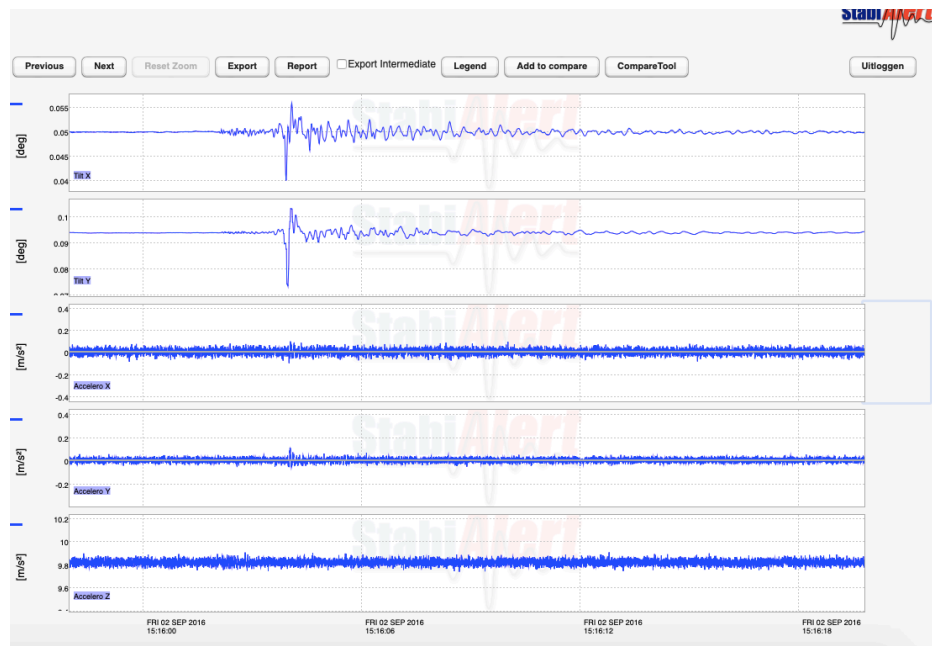
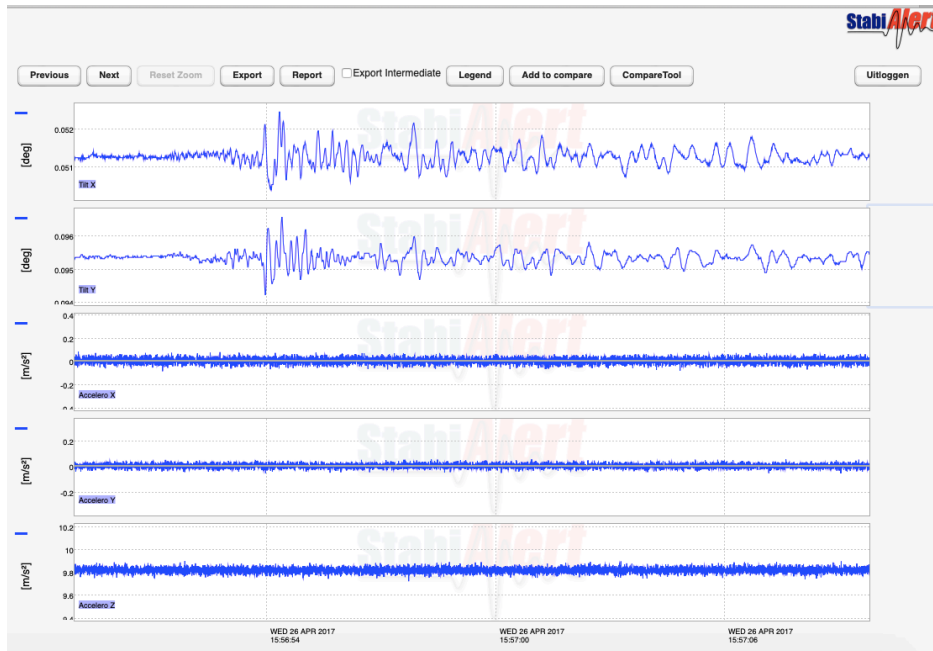
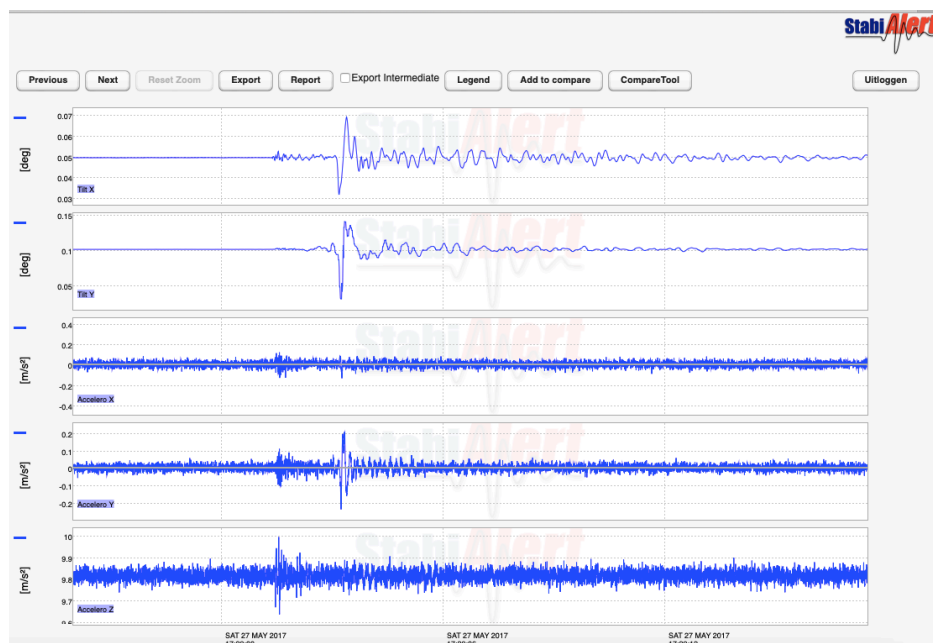
Figure 2. Tilt and acceleration readings from the event on 2016-02-25

Figure 3. Tilt and acceleration readings from the event on 2016-09-02

Figure 4. Tilt and acceleration readings from the event on 2017-04-26

Figure 5. Tilt and acceleration readings from the event on 2017-05-27

It can be seen in Figure 2 to Figure 5 that the tilt values during the earthquake come back to the original rotational position right at the end of the earthquake. In other words, it seems at first glance that the earthquake motion does not leave a significant level of residual deformation or damage. However, further analysis and insights to the data have proven that the correlation of the damage to the tilt values is not a straight-forward issue, as explained below.

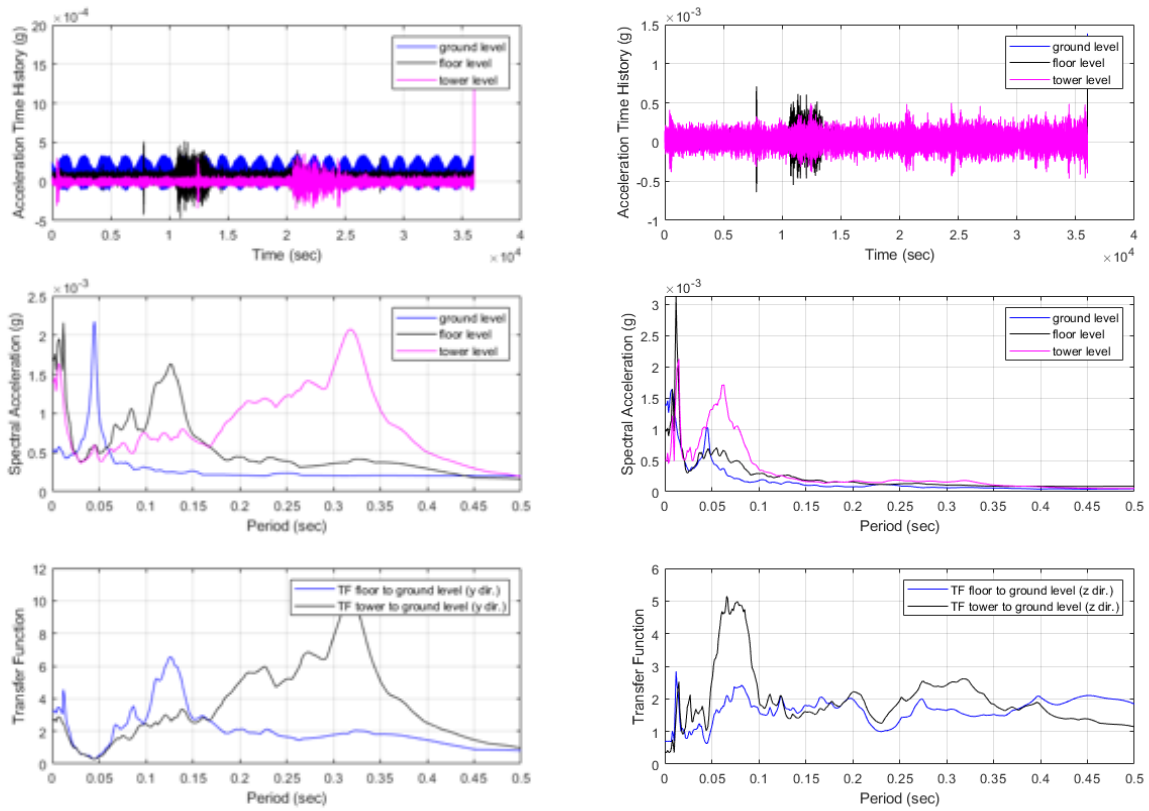
Figure 7. Accelerometer recordings, response spectra and transfer functions in Y and Z directions from 08-08-2018 Appingedam Earthquake ($M_L 1.9$)

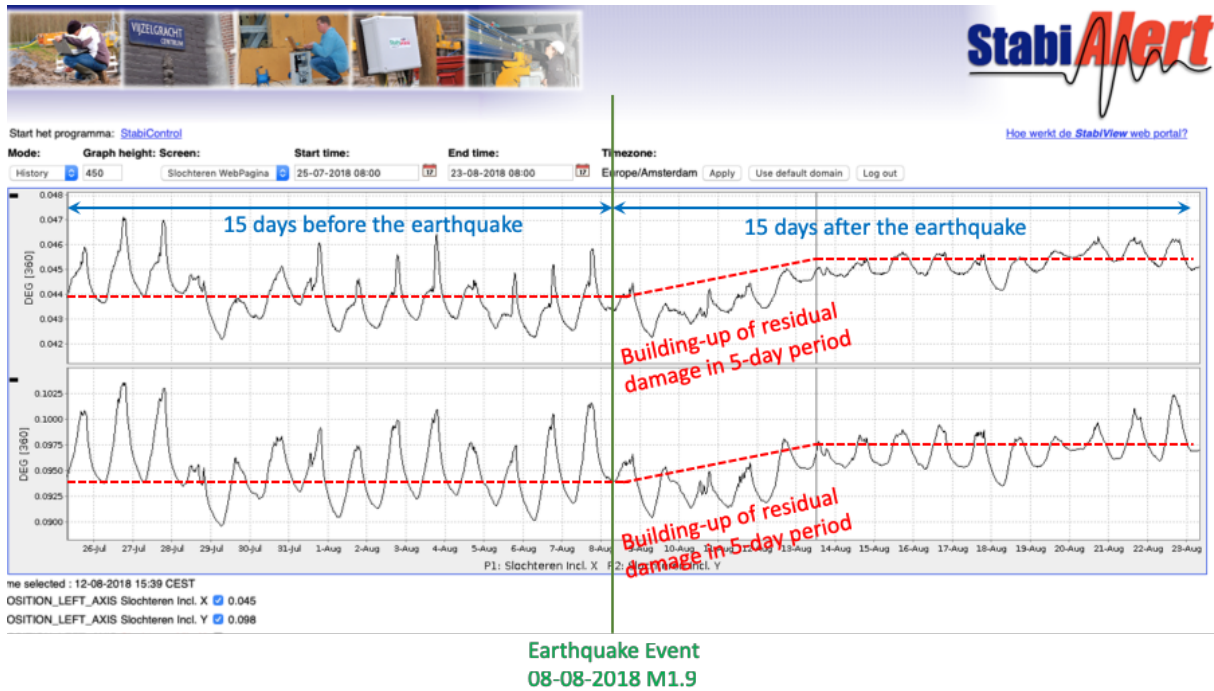
More interesting results can be seen when the tiltmeter data of 15 days before and after the earthquake are analysed. Although the tilt values do not provide insights regarding the damage on the building for such small earthquakes, for the seconds during the shaking, they do provide very valuable information for the hours and days following the earthquake. It can clearly be seen in Figure 8 that the tilt values fluctuate between the daily maxima and minima before the earthquake. There important things happen in the following days after the earthquake, as shown in Figure 8:

1. The average tilt position starts increasing, meaning that the monitored location of the structure starts leaning.
2. Leaning keeps increasing for the 5 days following the earthquake, very slowly, stabilizing at the end and creating a new average position. This new average position has higher tilt values than the average before the earthquake, meaning that some residual deformation and damage occurred in the meanwhile.
3. The difference between maxima and the minima in the daily changes decreases (smaller fluctuations), a fact that can be explained by high stresses developing in the soil and in the structural elements.

Figure 8. Tiltmeter data from the base of Fraeylemaborg, 15 days before and after the 08-08-2018 Appingedam Earthquake
